Case Studies – On-Line dry chemical cleaning of Furnaces

(1) Reformer Heater – radiant section (TX, USA)

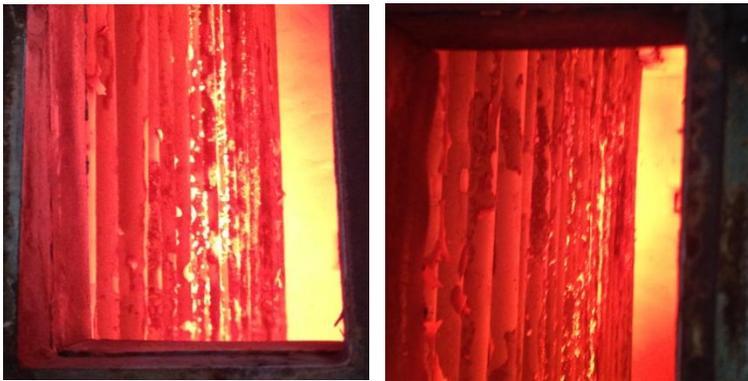
Gas-fired reformer heater, where the scale was formed by dust and fuel impurities. The refractory was ceramic fiber which is very sensitive to mechanical impacts.

Before cleaning: Extensive scale, hot spots, pieces of refractory

The cleaning results were excellent as you can read below. There was no damage to metallurgy (tubes and construction) or refractory.

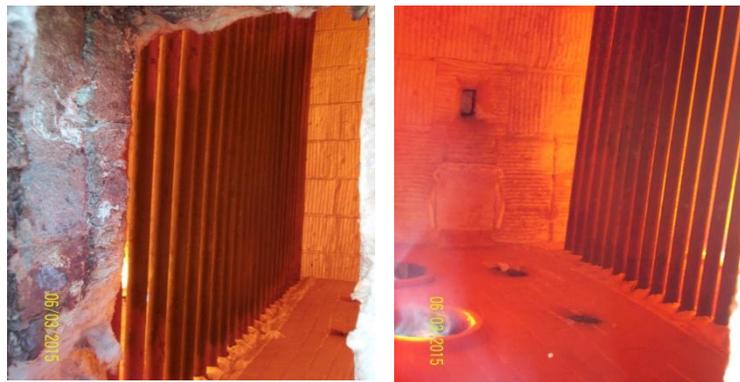
After cleaning: Tubes are clean; refractory (ceramic fiber) is undamaged

1. About 1 psig reduction in fuel gas pressure.
2. Fuel gas control valve opening dropped about a 3%
3. All the skin temperatures increased which may suggest the heat transfer improved.
4. Fuel gas consumption dropped about 2000 scfh

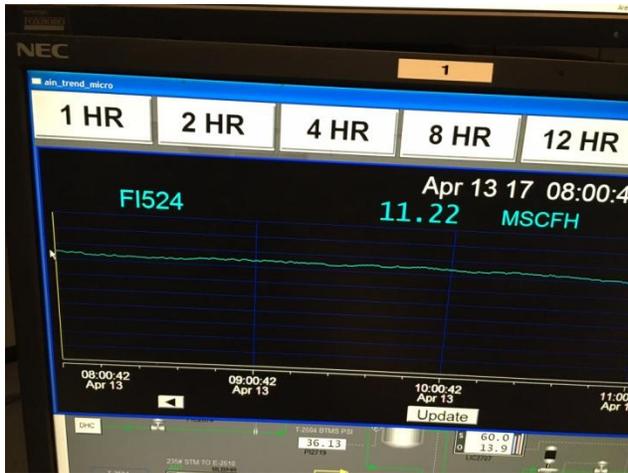
(2) Crude Heater 501 – radiant section (LA, USA)

Before cleaning: fuel consumption 11.2 MSCFH (million square cubic feet per hour)

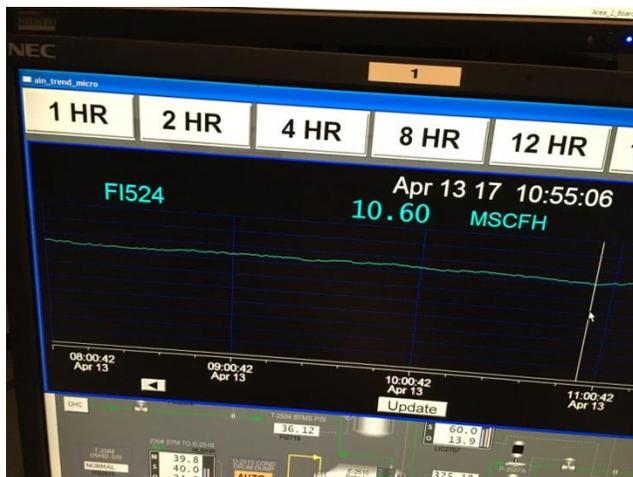
After cleaning: fuel consumption 10.6 MSCFH (million square cubic feet per hour)

Result: fuel consumption is decreased by 5.4%

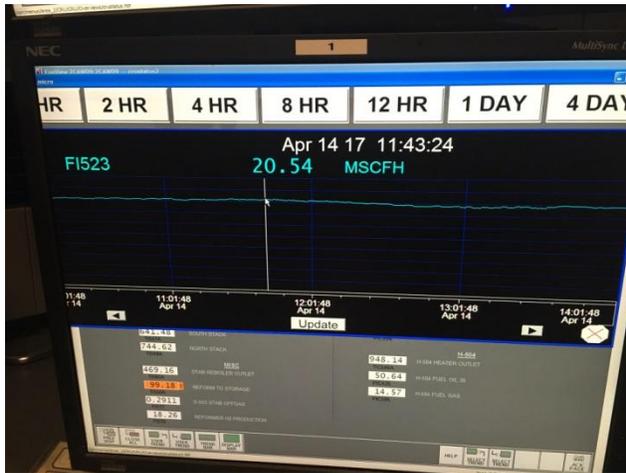
(3) Crude Heater 502 – radiant section (LA, USA)

Before cleaning: fuel consumption 20.54 MSCFH (million square cubic feet per hour)

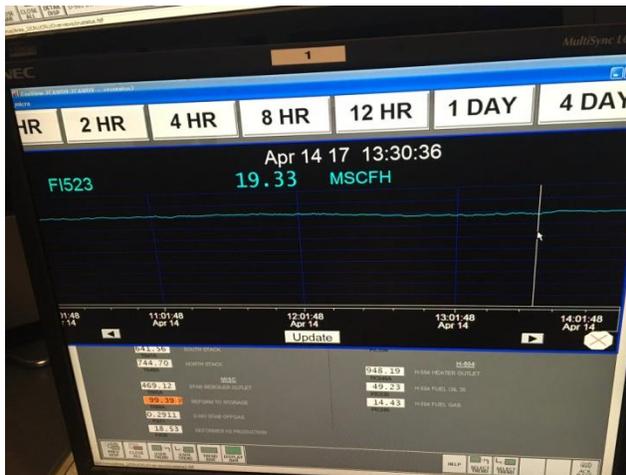
After cleaning: fuel consumption 19.33 MSCFH (million square cubic feet per hour)

Result: fuel consumption is decreased by 5.9%

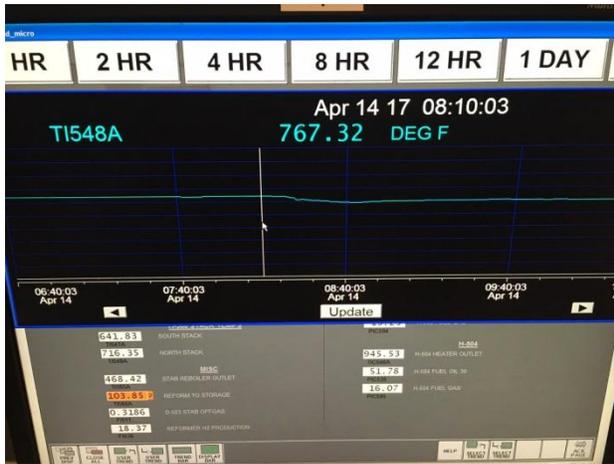
(4) Heater 503 – convection section (LA, USA)

Before cleaning: North stack temperature 767 F

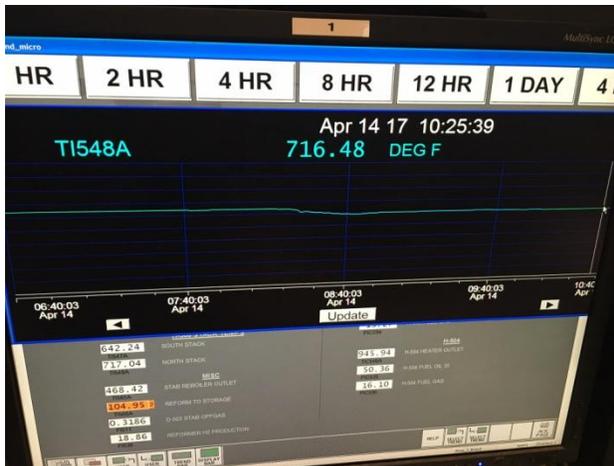
After cleaning: North stack temperature 716 F

Result: North stack temp. is decreased by 51 degrees

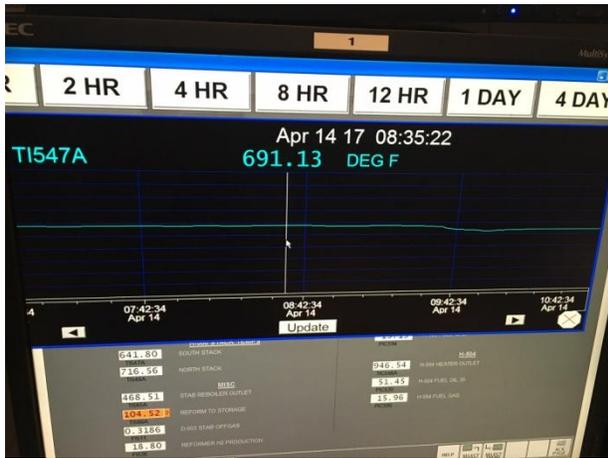
(5) Heater 504 – convection section (LA, USA)

Before cleaning: South stack temperature 691 F

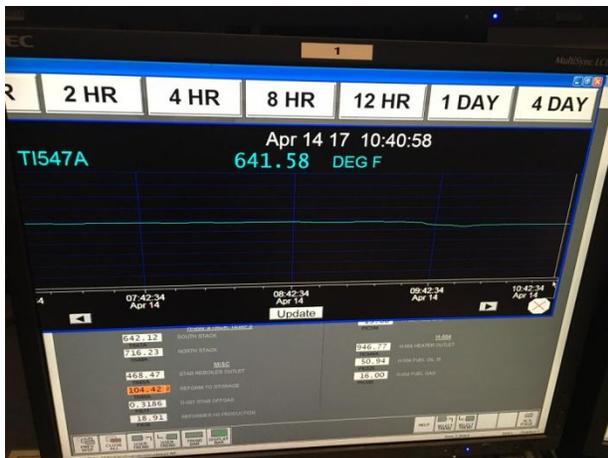
After cleaning: South stack temperature 641 F

Result: South stack temp. is decreased by 55 degrees

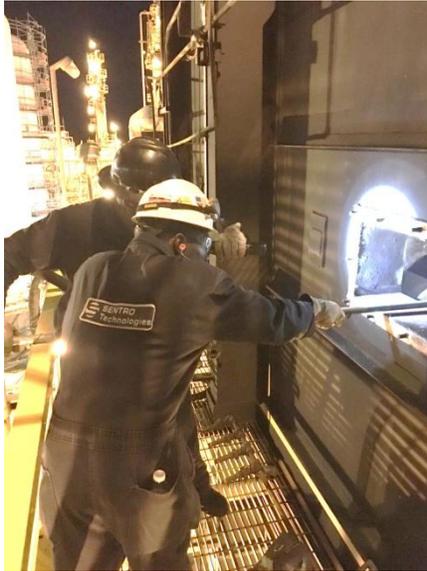
(6) Convection section cleaning (CA, USA)

Dirty tubes

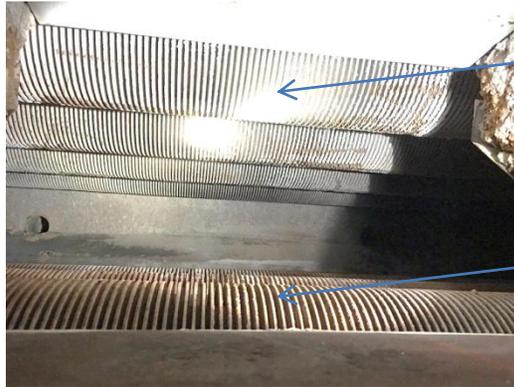
Clean tubes

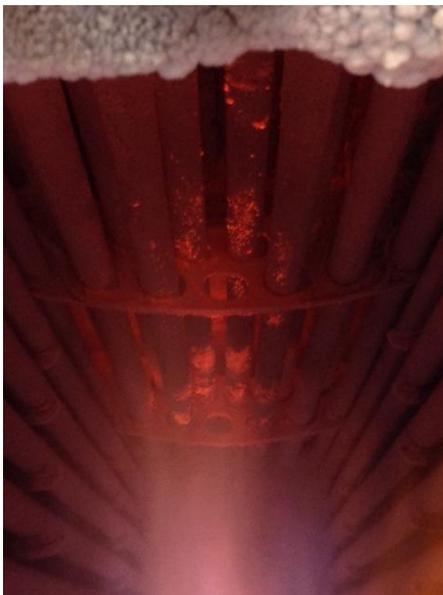
(7) Radiant section cleaning (KS, USA)

Dirty radiant shock-tubes before cleaning, with scale and hot spots

Result: all scale and hot spots have been removed.

Thermal efficiency of the heater has been significantly increased
